Manhole Inspection Summary

Manhole # S150O1025MH

Location Address: **4818 GREENSPRING AVE**

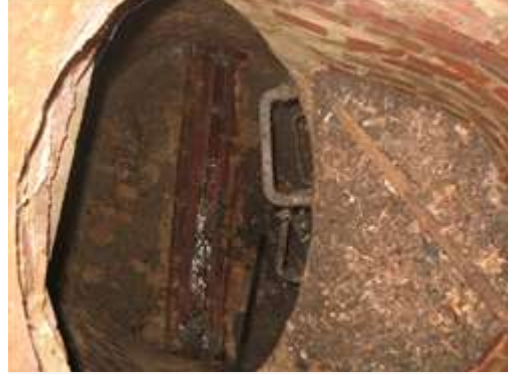
Top View

Frame leaks. Adjustment deterioration and infiltration. Barrel infiltration. Evidence of surcharge - Bench debris.

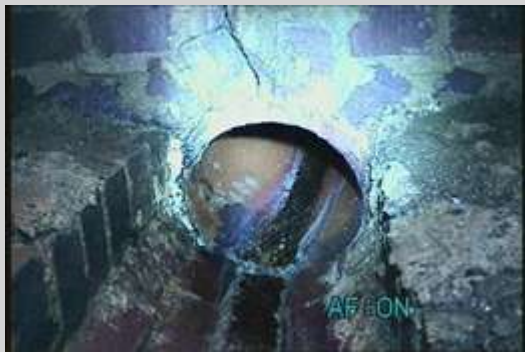
8 in. Circular Gravity Sewer Pipe Out @ 12 O'Clock

Infiltration: **Evidence** Pipe Seal Cond: **Cracked**

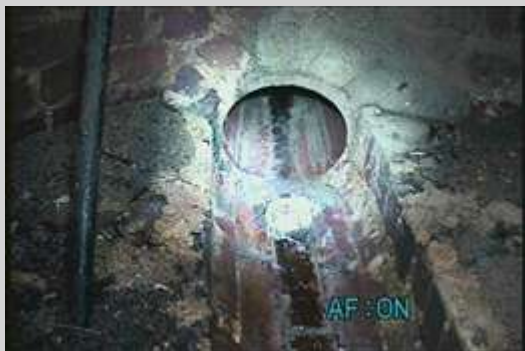
8 in. Circular Gravity Sewer Pipe In @ 6 O'Clock

Infiltration: **Evidence** Pipe Seal Cond: **Unknown**
